MBIE AND EQC

SURVEY OF SEISMIC RESTRAINT OF NON STRUCTURAL ELEMENTS IN EXISTING COMMERCIAL BUILDINGS

Report on Stage 2 – Full Study Volume 1

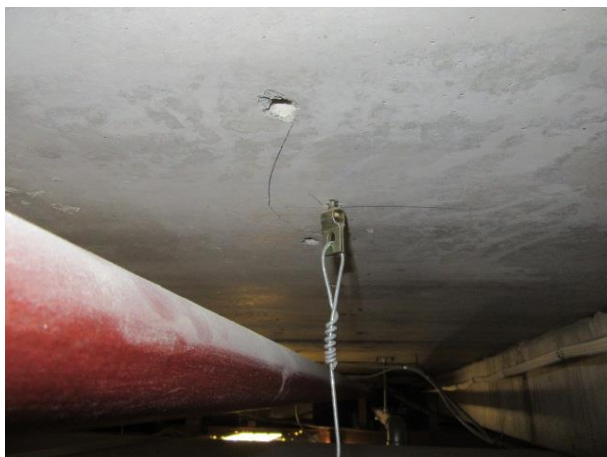
6mm Dynabolt pulling out of Hollowcore concrete slab

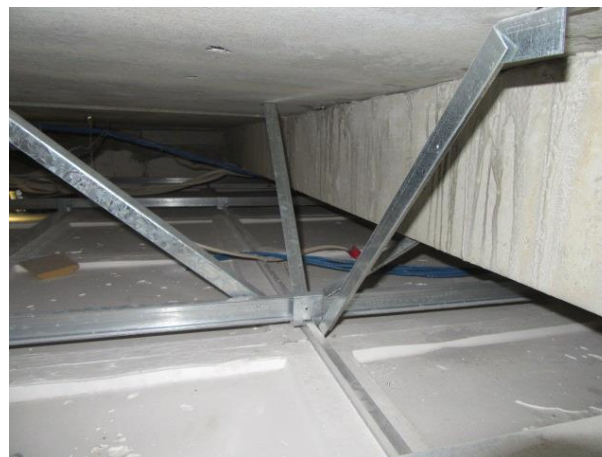
Ceiling bracing. Weakest element is 3.6mm aluminium rivet fastening to grid. Dynabolts in Hollowcore also failing

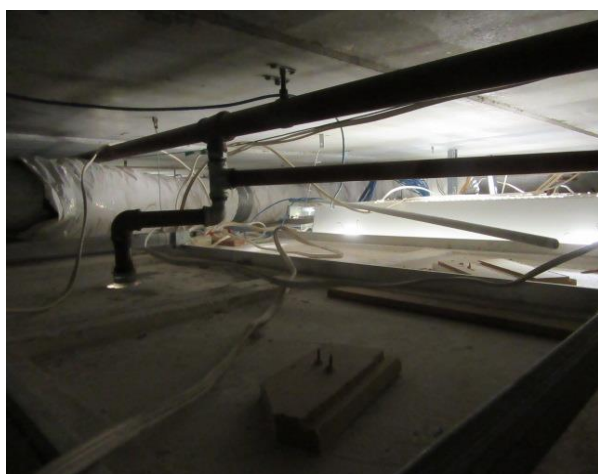
Fire sprinkler within 150mm of slab, unrestrained light (not supported independently), soft ducting unrestrained over 3m length.

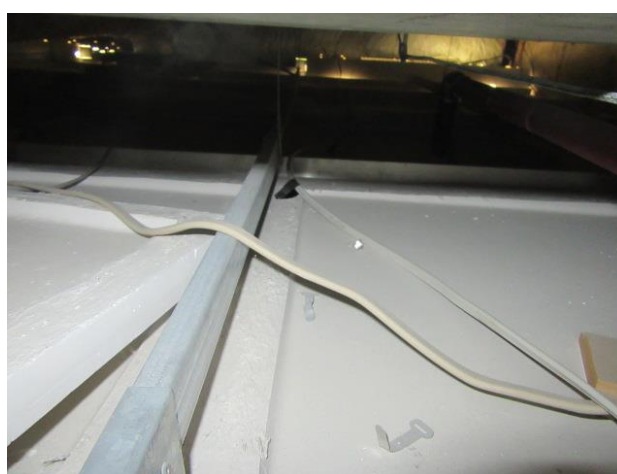
Electrical wires laid directly on ceiling.

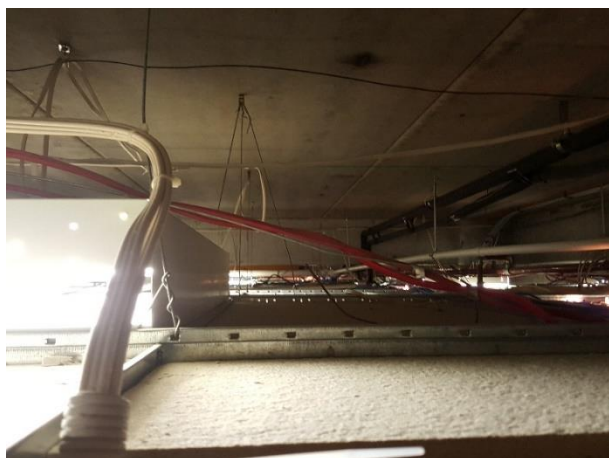
6mm Dynabolt pulling out of Hollowcore concrete slab

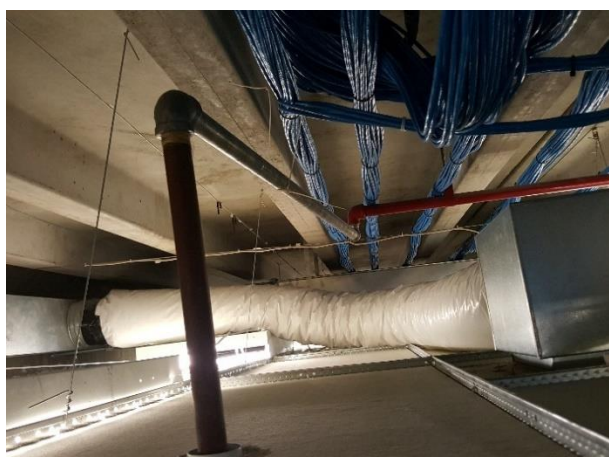
Range supported by cable tie, unbraced

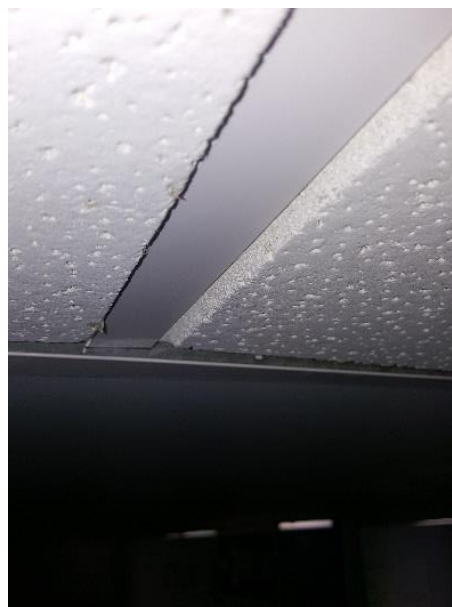
Grid ceiling to rondo ceiling not fastened

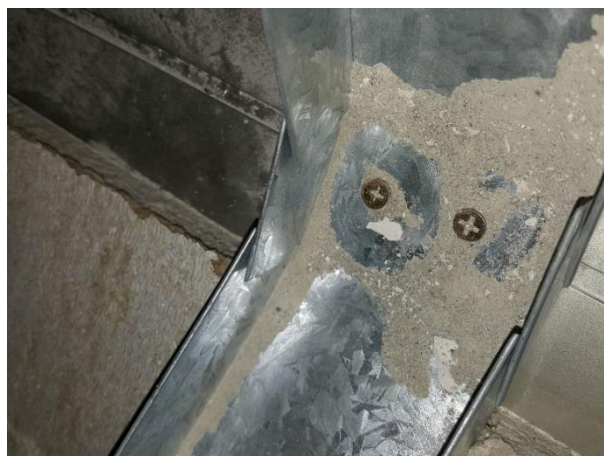
Partition wall bracing let down by fasteners

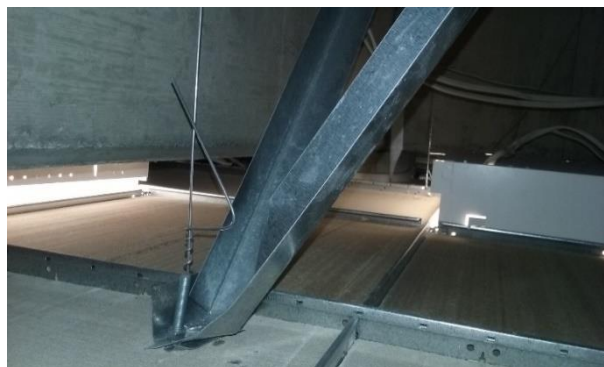
Partition wall poorly braced

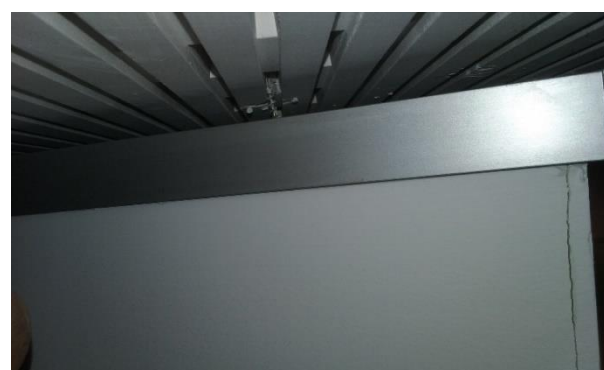
Partition wall to plaster ceiling fastening

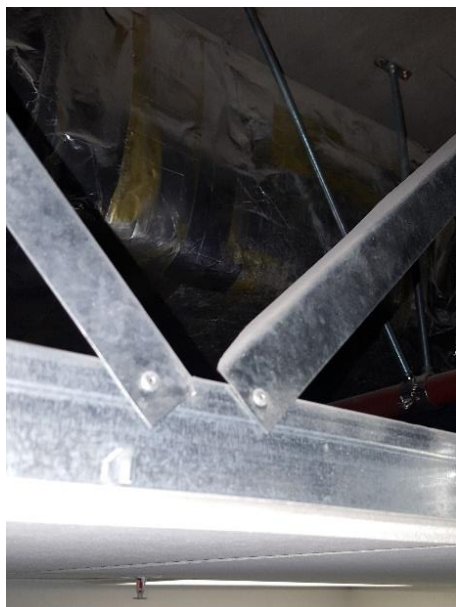
Ceiling bracing let down by weak fastener at element, note poor angle of fire brace in back ground

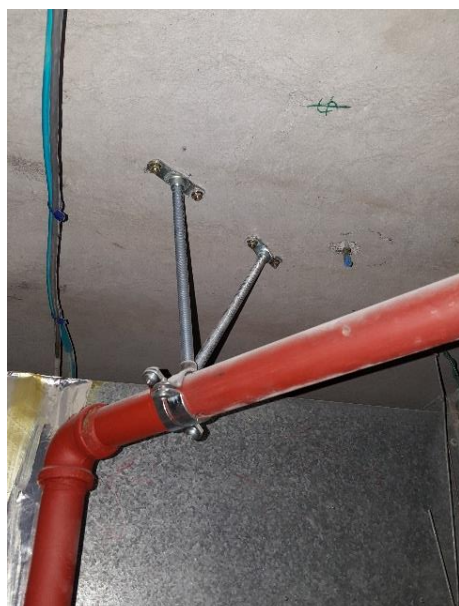
Ceiling bracing let down by weak fastener at element, note poor angle of fire brace in back ground

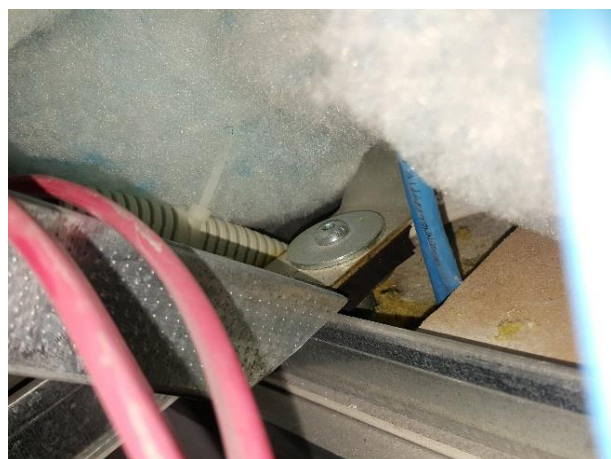
Track-lok bracing of partition walls

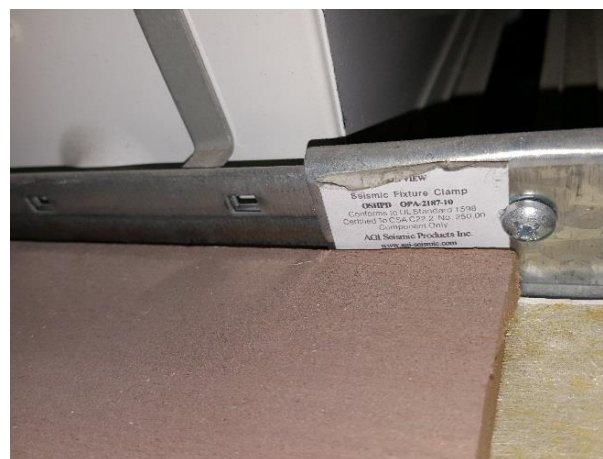
Grid fastened around lights

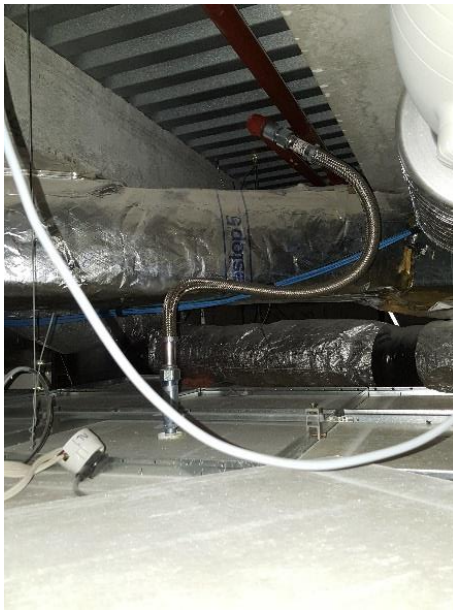
Flexible range
