Economic Benefits of Code Compliant Non-Structural Elements in New Buildings

Ministry of Business, Innovation & Employment

Date: 20 March 2017
Reference: 6-DP292.01
Status: Final

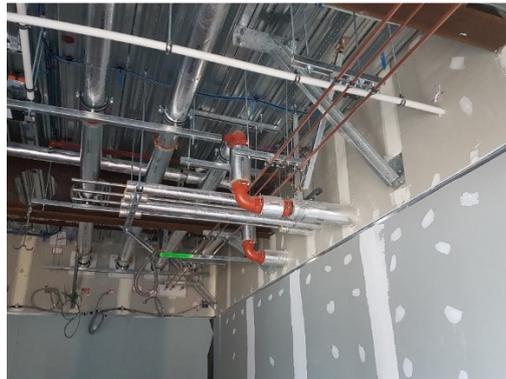
Figure 1: Seismic Restraints of Services

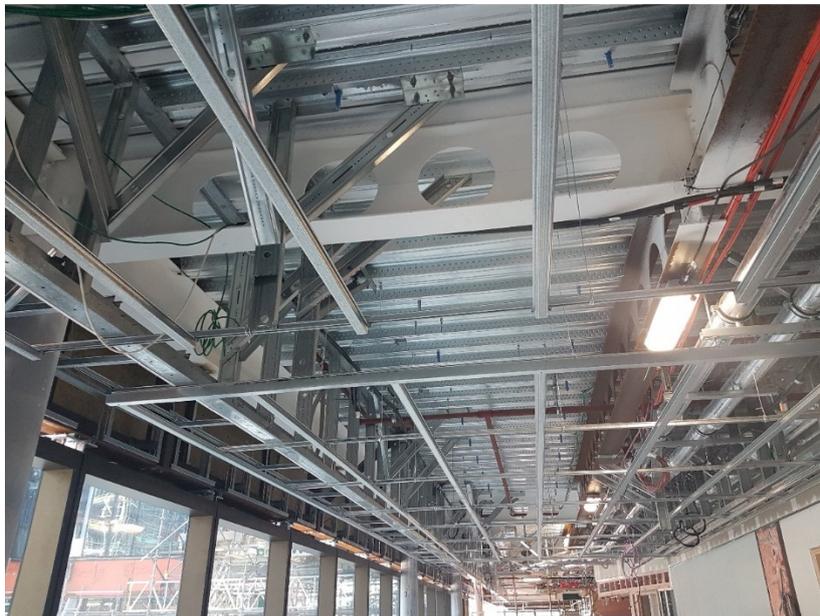
Figure 2: Seismic Restraint of Services and Ceilings

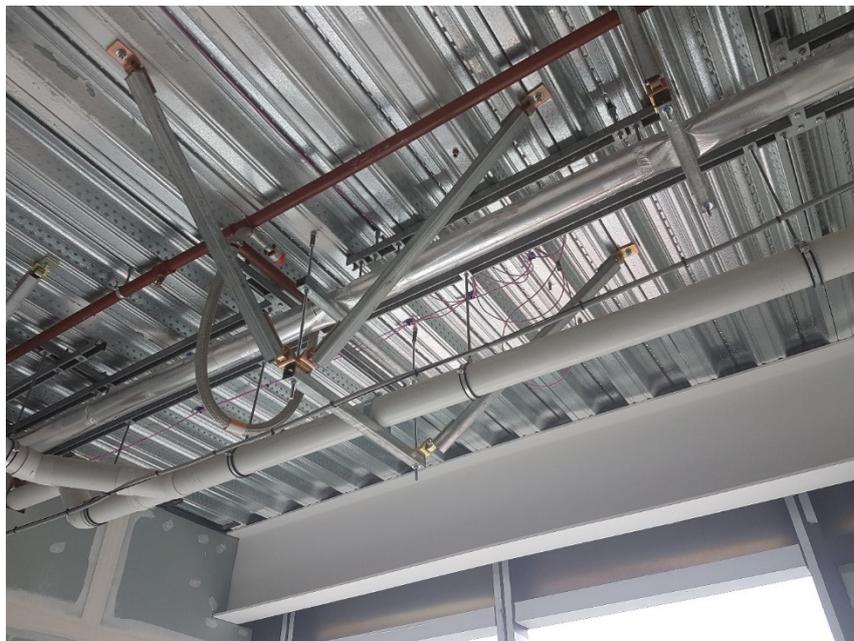
Figure 3: Seismic Restraint of services

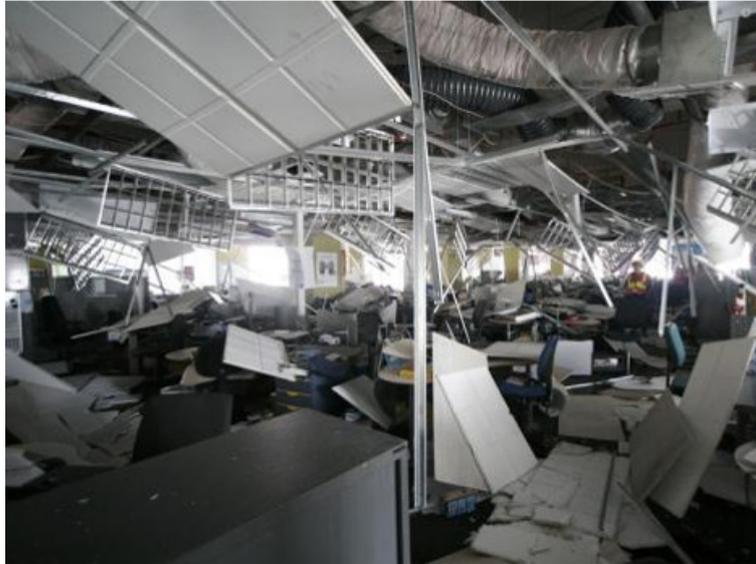
Figure 4: Failure of ceilings and services in Christchurch commercial building

Lighting systems, in particular those associated with suspended tile ceilings, but also longer channel lighting systems, regularly failed and fell into the rooms below. As noted for the failure of the HVAC supports, failure of lighting systems indicates that they had not been designed and/or installed in accordance with NZS 4219. Often the installation does not meet the requirements of NZS 4219 because the minimum clearances and coordination with other services and ceilings has not been appropriately considered.

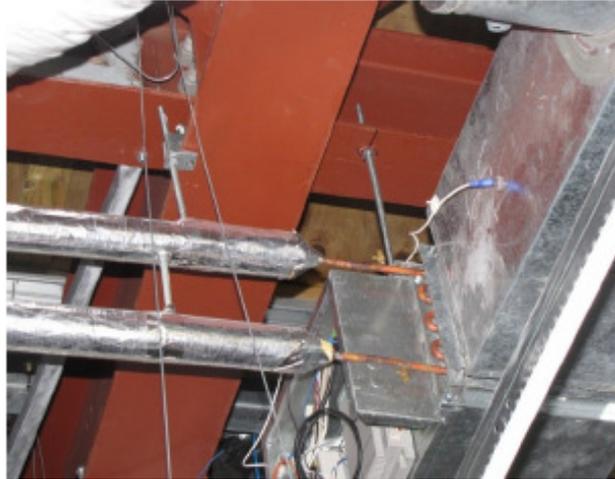
Figure 5: Lack of flexible connections to mechanical plant

- Equipment suspended within ceiling voids was, in some cases, found to not comply with Clause 5.2.2 of NZS 4219 which requires flexible connections when services and ceilings are not supported together. Examples of non-compliance included unrestrained pipe branches connecting to unrestrained ventilation equipment, without a flexible connection.
- Mechanical equipment weighing in excess of 10kg was found to be unrestrained. This does not comply with Clause 5.9 of NZS 4219.

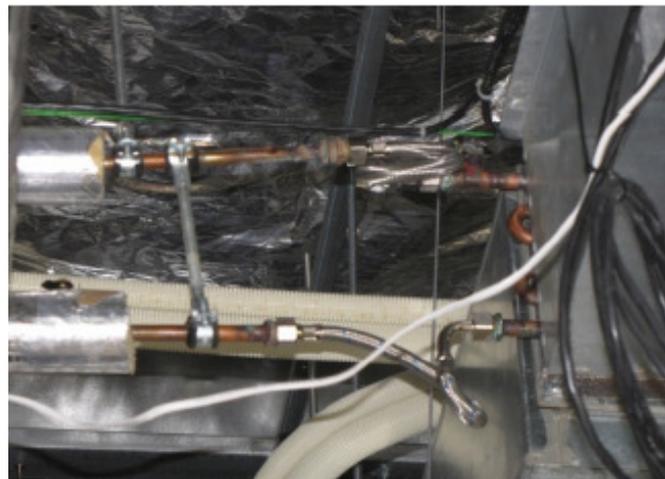
Figure 6: Use of flexible connections on mechanical plant to achieve compliant installation

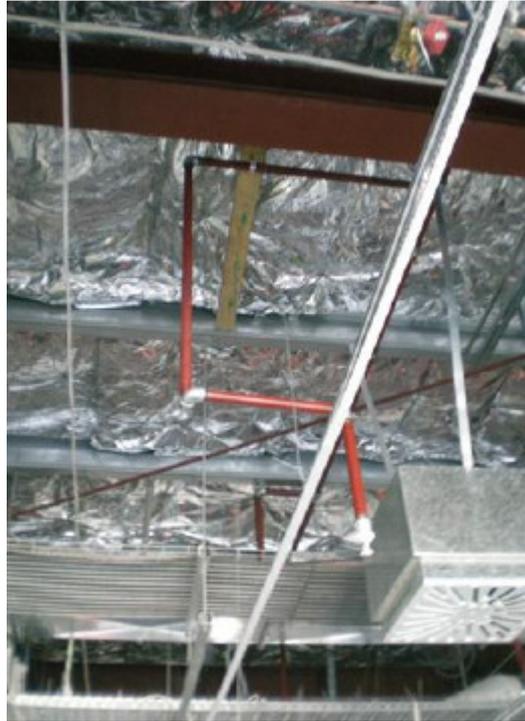
- Ventilation grilles and diffusers weighing in excess of 10kg were observed to be unrestrained. This does not comply with Clause 5.9 of NZS 4219 and leaves the equipment at significant risk of failure. The economic cost of failure of the diffuser needs to be considered in the context of what is around the diffuser/grille. The damage and associated repair costs is likely to be more than just the diffuser/grille itself, as the effect of this equipment swinging around is likely to cause damage and require repairs to nearby pipework, connections, equipment, ceiling hangers and other near-by services, and may also cause suspended ceilings and other equipment to fall and render the area unusable and cause interruption to business operations.

Figure 7: Unrestrained diffusers

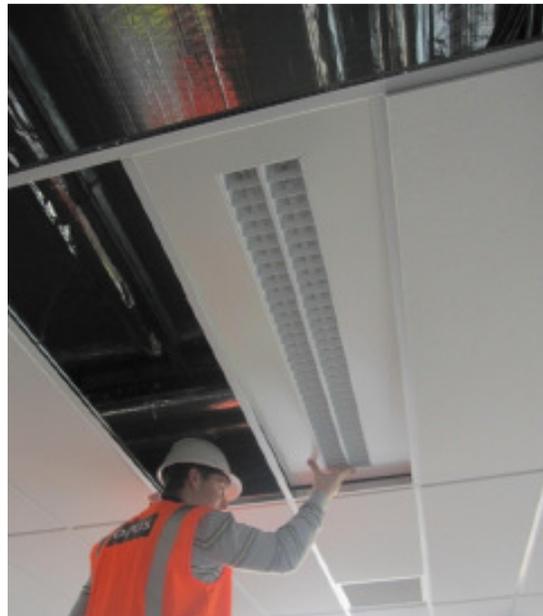
- Luminaires dislodged from ceiling grids
 - Installations were observed where recessed luminaires did not appear to be positively fixed to the ceiling grid and therefore failed to comply with Clause 5.14 of NZS 4219. The weight of recessed luminaires can be significant and if they fall they risk injuring occupants below and causing business interruption.

Figure 8: Unsecured recessed luminaires

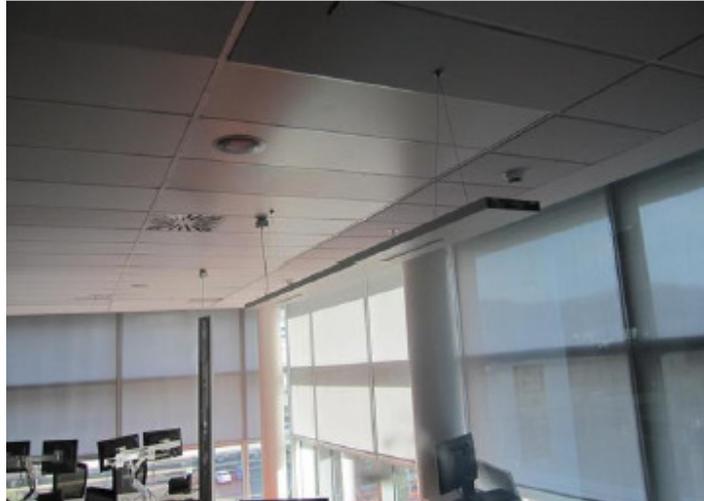
- Freely suspended luminaires suspended on stay wires from ceiling tiles were observed. The use of vertical stay wires does not meet the requirements of NZS 4219 - Clause 5.14 as it allows the luminaire to move in an earthquake and impact with the building or other equipment. In some instances the support wires broke causing the luminaires to fall.

Figure 9: Typical suspended luminaire

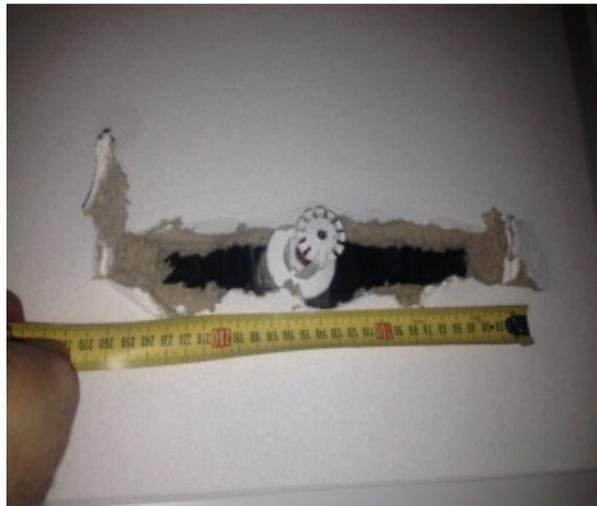
- Direct connection of sprinkler droppers to fixed cable tray and ductwork supports did not meet the code (NZS 4541) requirement that the sprinkler pipes and joints will not experience undue deflection. In particular failure was observed when the dropper arm was connected to heavily loaded unrestrained cable tray. The costs of consequential damage and business interruption due to failure of the sprinkler head is substantial with the potential for water damage that drains to multiple floors.

Figure 10: Relative movement of sprinkler and ceiling

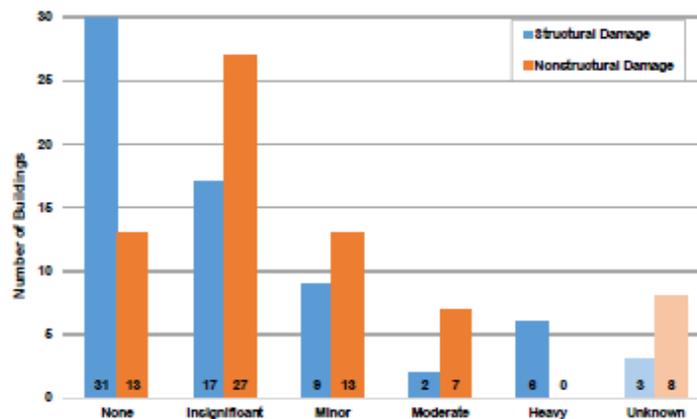
The following graph shows the distribution of commercial building damage according to the general damage classification. 80% of the buildings in the 300m radius of the strong motion recording station were observed to have some degree of non-structural damage, whilst 54% were observed to have some degree of structural damage.

Figure 11: Distribution of building damage according to general classification

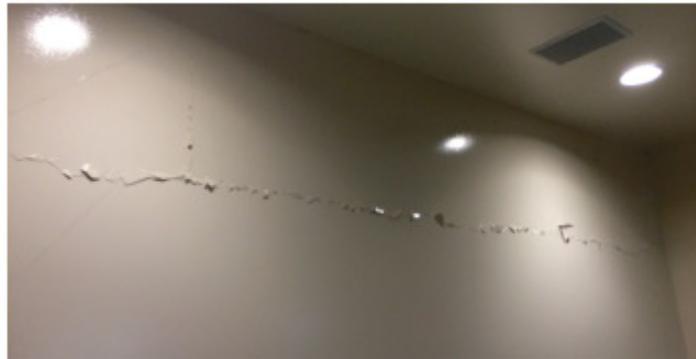
Figure 12: Cracked gypsum board wall in hospital

Both new and older hospital buildings experienced some non-structural damage which, in a larger earthquake with longer duration, could have impacted the continuity of service. In particular, damage to walls and ceilings in operating rooms was observed to have affected the ability to maintain the required positive air pressure and the required number of air changes, thus impacting the sterile environment.

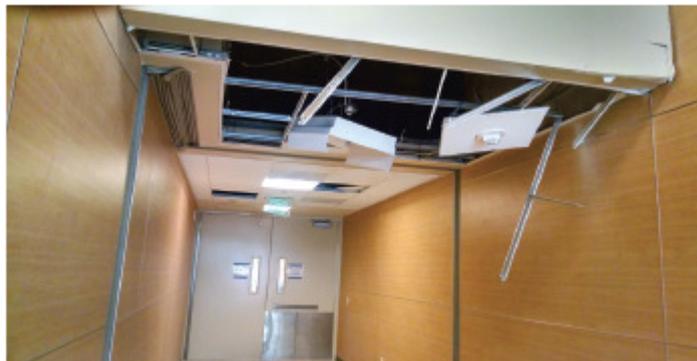
Figure 13: Ceiling damage in hospital corridor link

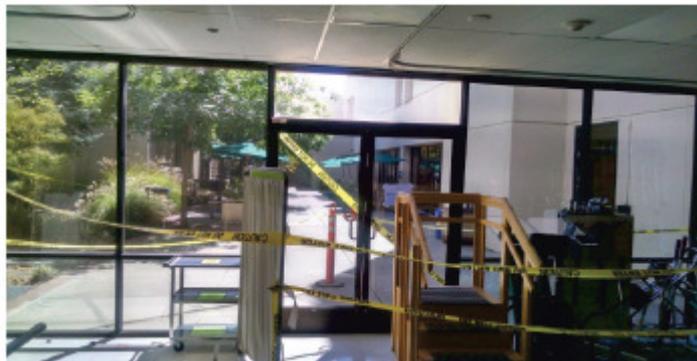
Figure 14: Damage to glazing leading to entrance being posted as "restricted use"

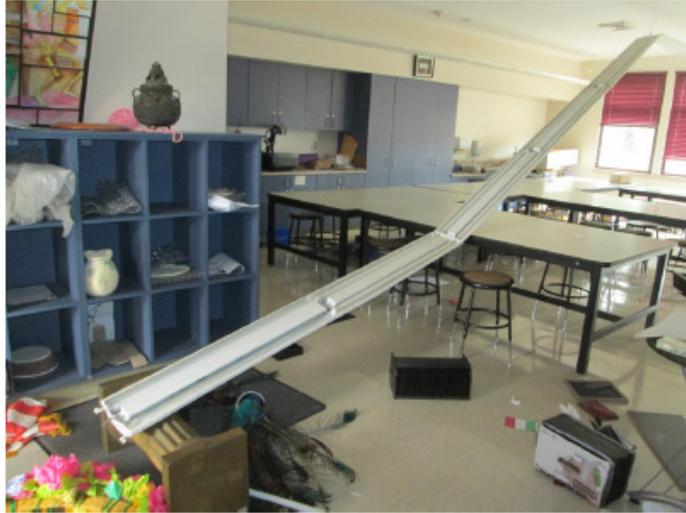
There was little or no structural damage to schools due to the Napa earthquake. Several schools did, however, experience non-structural damage to architectural, mechanical or electrical elements including suspended ceilings, light fixtures, equipment and furniture. Some of the elements (ceilings, mechanical and electrical elements) that fell from above could have been life threatening had the earthquake occurred during school hours.

Figure 15: Damaged light fixtures - commonly observed in school facilities

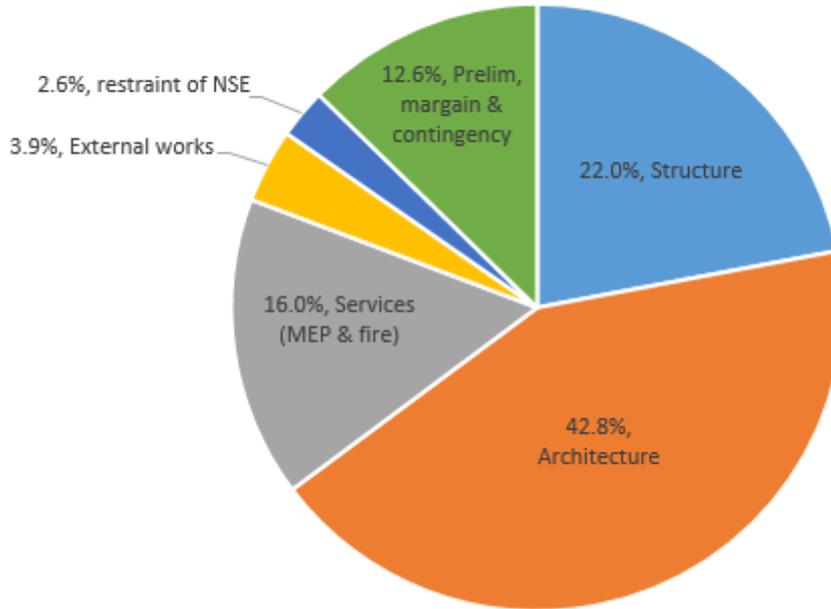
Fire Station - single storey

The following charts show the cost breakdown of building elements for each of the chosen study buildings. The dark blue pieces represents the cost to provide seismic restraints to the ceilings, partitions, mechanical, electrical, plumbing and pipework and sprinkler systems.

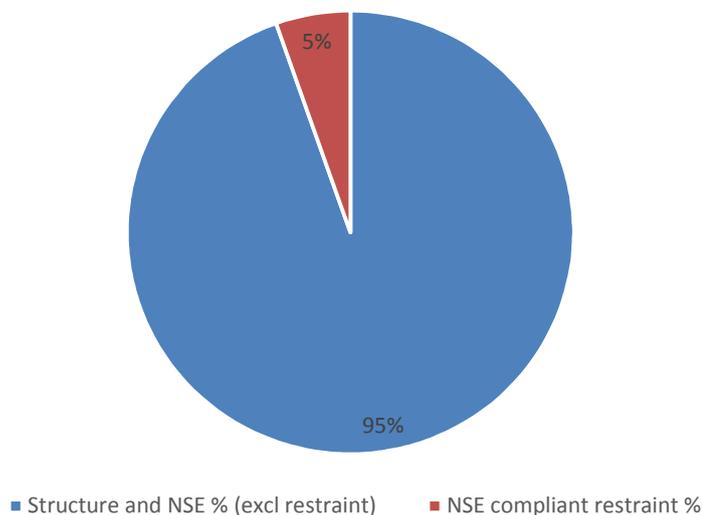
Average annual NZ Construction value (2016)

While the minor ‘Heavy Industry / Energy’ and ‘Sports’ categories are not covered in the table above these account for only \$700m. For the remainder of the \$8.7b of non-residential building construction in New Zealand the cost of NSE restraint can therefore be extrapolated be in the order of \$423m or around an average of 4.9% of the total annual construction spend.

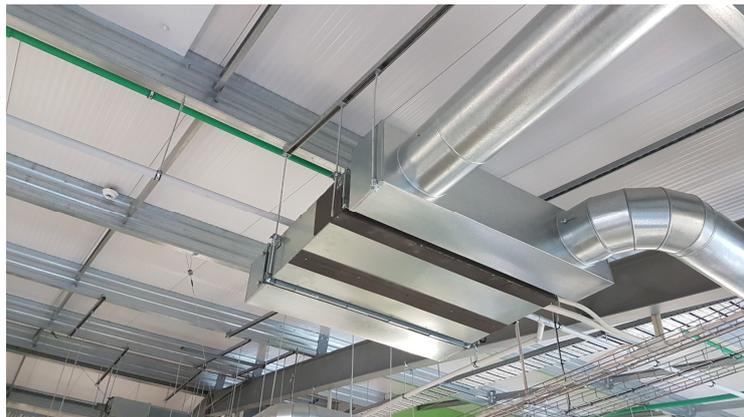
Figure 16: Non-compliant installation of overhead mechanical plant (no lateral restraint provided) – building completed and received Code Compliance Certificate 2015

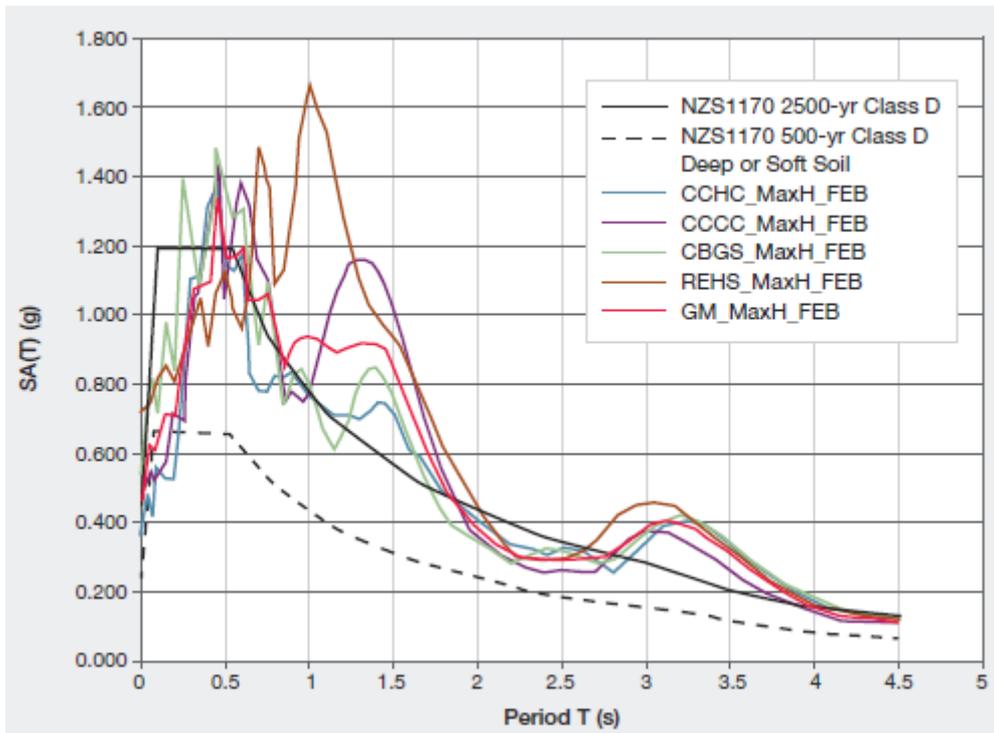
The most destructive earthquake of the Canterbury earthquake sequence was the Mw 6.2 earthquake which occurred at 12.51pm on 22 February 2011 with an epicentre under the Port Hills. The resulting horizontal ground motions reached 1.7g in the Heathcote Valley near the epicentre and up to 0.8g in the CBD. Vertical accelerations of 2.2g were recorded in the Heathcote Valley. The ground motions significantly exceeded the design 500-year return period earthquake for Christchurch as can be seen in the following figure.

Recorded response spectra in Christchurch CBD compared with NZS 1170.5 for deep soil sites
